SUBJECT: Unannounced Inspection of ADM
Sullivan, Indiana

Facility: ADM grain elevator

Location: Sullivan, Indiana

Inspection Date: September 4, 2013

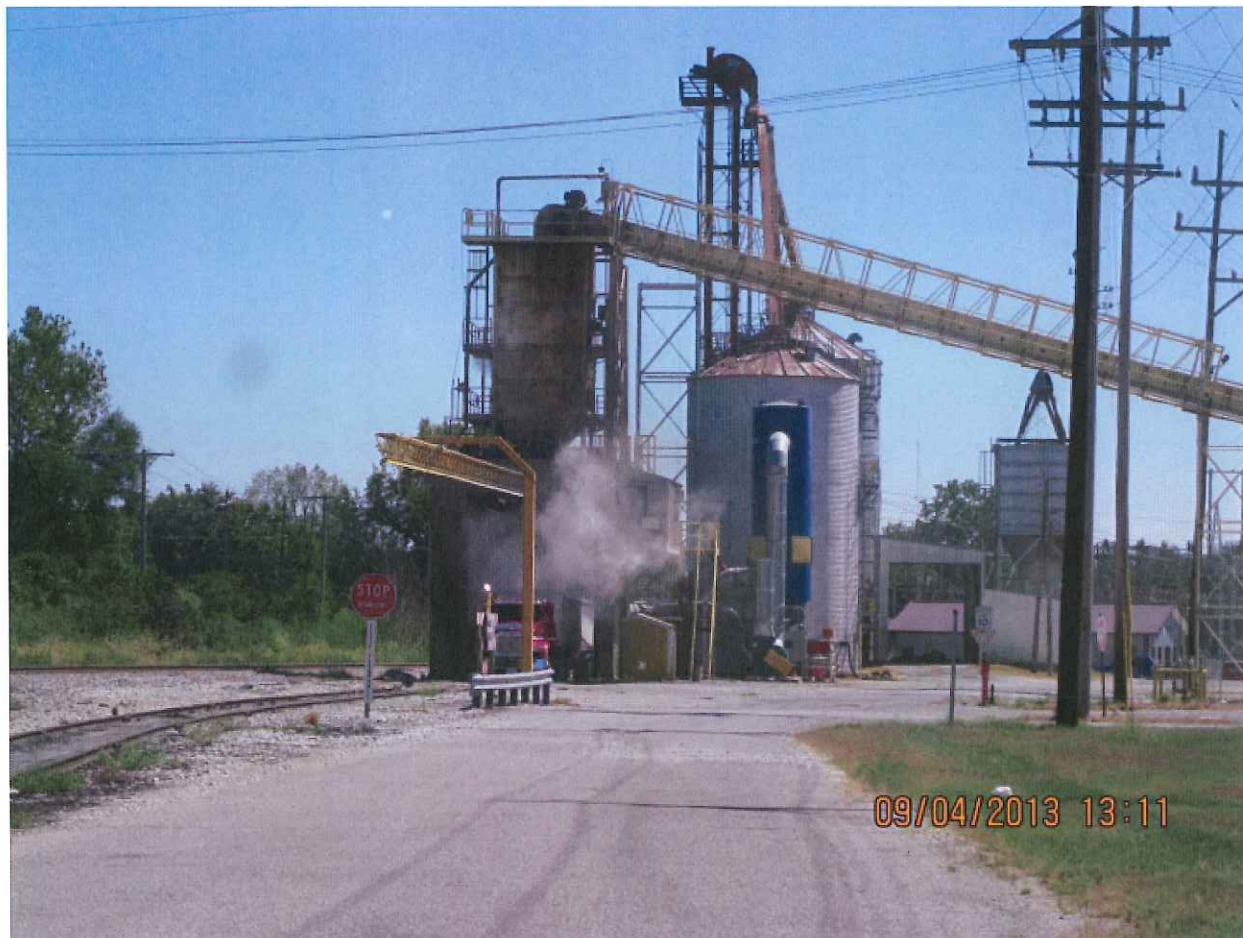
Katy Bellairs, Andrea Alltop, and I arrived at the ADM grain elevator (Facility) in Sullivan, IN about 3:15 P.M. on September 4, 2013. As we pulled up to the Facility, we saw a truck being loaded with grain. Ms. Bellairs walked towards it and started doing a Method 9 opacity reading. While doing the reading, an employee of the Facility approached Ms. Bellairs and asked her what she was doing. She explained that she was watching the process and trying to do a Method 9 reading. Ms. Bellairs was unable to complete a full six minute reading because the Facility stopped loading the truck less than six minutes after she started reading. However, there were significant emissions during the loading process as shown in Figures 1 and 2. Emissions were being emitted from the distributor during the loading process as well.

Figure 1: Visible emissions and a lot of opacity were seen as a truck was loaded with grain.

There is only one loadout and it is able to load trucks and railcars. This loadout has a baghouse, but we observed significant emissions of particulate matter while a truck was being loaded despite the fact that the baghouse was operating. There is also a sock on the loadout and a representative of the Facility said it extends six inches into the vehicles while they are being loaded. We were not standing close enough to the loadout while the truck was being loaded to determine if this is correct. When I asked the representatives how much of the grain is shipped by rail and how much of it is shipped by truck, a representative of the Facility said it varies. Some years 80% is shipped by rail and other years 5% is shipped by rail. ADM plans to add a truck loadout in the East Pit.

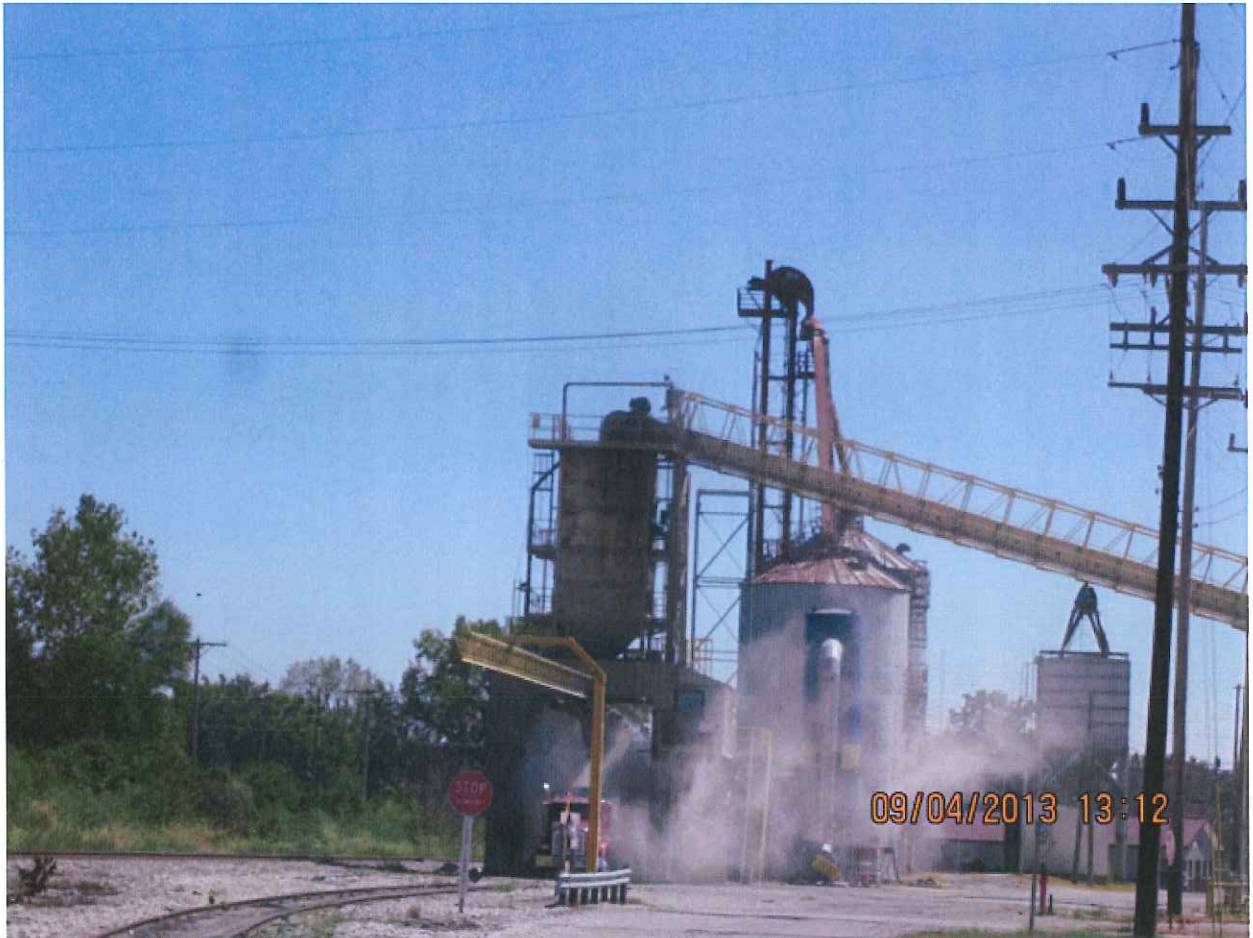
Figure 2: Another picture of the truck being loaded with grain.
